AVIATION INVESTIGATION REPORT
A04H0001

LOSS OF CONTROL

GEORGIAN EXPRESS LTD.
CESSNA 208B CARAVAN C-FAGA
PELEE ISLAND, ONTARIO
17 JANUARY 2004

Report Number A04H0001

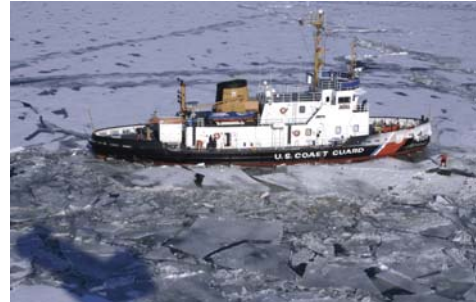
Photo 1. USCG ship *Neah Bay*

At the time of the accident, the lake was covered with ice from 2 to 12 inches thick. The water depth around Pelee Island was approximately 20 to 26 feet. When the first responder, a United States Coast Guard (USCG) helicopter, arrived at the crash site, the entire empennage was visible above the water. The empennage was observed to sink beneath the surface of the lake approximately four hours after the occurrence. The sinking coincided with the arrival on scene of the USCG ship *Neah Bay* (see Photo 1). Some pieces of debris from the aircraft, such as the cargo pod and engine cowling, were recovered from the surface of the ice.

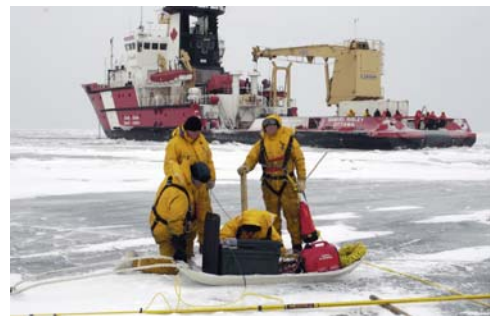
Photo 2. CCGS *Samuel Risley*

Foul weather and extreme changes in temperature also hampered the search. During the 13-day search and recovery, the team dealt with temperatures that ranged from 0°C to -20°C, in both calm and gale force winds, and in both rain and snow. All these factors affected the ability of teams to work safely on the ice (see Photo 2).
